# Smoke and Dye Testing Summary

## High Level Sewershed

Run Summary							
Test ID	Test Type	Date Inspected	Company / Super.	Nearest MH	Ground Condition	Notification Made?	
D1028-159	Dye	4/22/2009	ADS/TM	S09AA1009MH	Damp	NA	
Address	3606 Copley Road		Location	Curb	Status	Public	Source Catch Basin

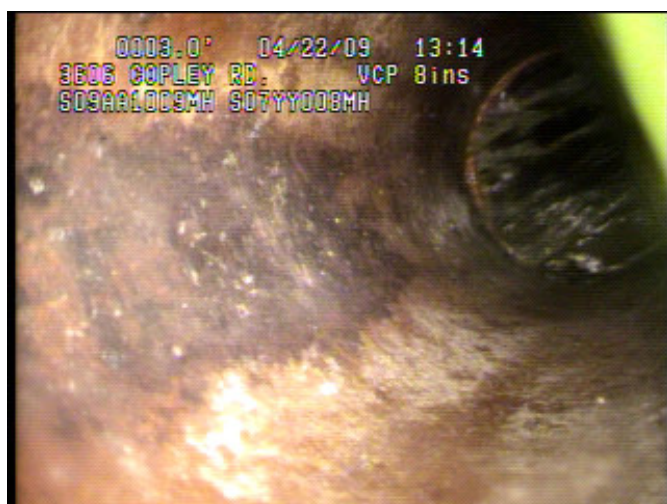
**Picture** \D1028-159-OB01-P01.jpg

**Comments** Dye observed 3 ft. downstream of S09AA1009MH.  
Infiltration gusher at joint from 10 to 2 oclock.

**Comments** 3 ft. downstream of S09AA1009MH along  
S09AA1009G1. Camera rotated 90 degrees  
counterclockwise.
